Nanofillers for Improved Flywheel Materials

September 2016

Project: Improved Flywheel Materials

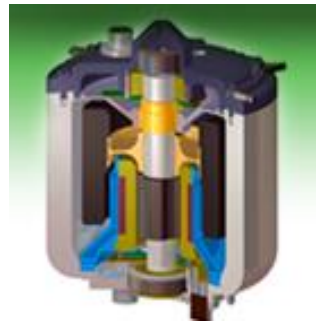
Energy is stored in the rotor as kinetic energy, or more specifically, rotational energy:

$$E_k = \frac{1}{2} \cdot I \cdot \omega^2$$

ω = angular velocity, I = moment of inertia of the mass about the center of rotation

The amount of energy that can be stored is dependent on:

$$s_t = \rho \cdot r^2 \cdot \omega^2$$

s_t = tensile stress on the rim, ρ = density, r is the radius, ω is the angular velocity of the cylinder.

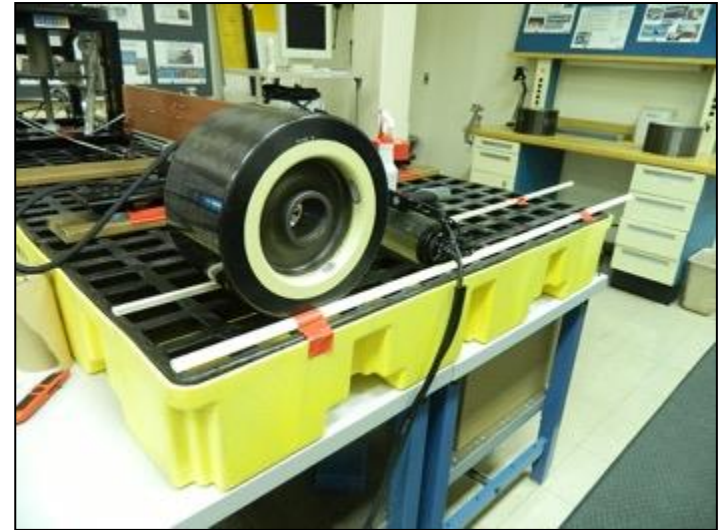
- Ultrasonic Contact Test 1 MHz/1.0" Diameter Transducer

Typical A-Scan Signal on all three flywheels

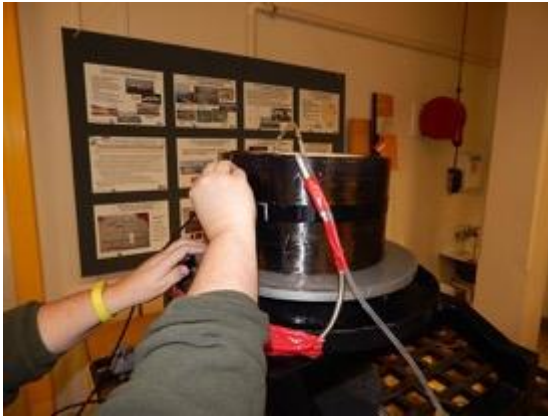
Part was scanned on a lazy Susan wheel indexed down the part $\frac{1}{2}$ of the transducer diameter
